## CASE STUDY: HVAC MALFUNCTION MUSTY ODORS

### **PROJECT DESCRIPTION: ODOR INVESTIGATION/REMEDIATION RETAIL BANK BRANCH**

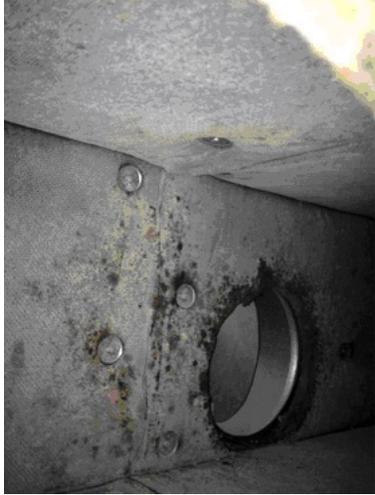
1. **Visual Inspection:** AET's CIH staff professional identified condensation on the exterior surfaces of the HVAC supply ductwork downstream from the cooling coil. Confirmation of moisture impact to fiberglass interior lining was performed by partially disassembling the ductwork. The extent and distribution of moisture impact throughout the HVAC ductwork was performed by core sampling/moisture measurement testing.
2. **Source Assessment:** The discharge temperature of the supply air downstream from the cooling coil was measured at 40°F. An average temperature of 55°F is recommended to control moisture condensation within ductwork (i.e. above the dew point).

**AET's Experience:** Fiberglass lined ductwork cannot be effectively cleaned. Although wet newly installed fiberglass does not actively support mold growth, the dirt/debris attached to the fiberglass in older ductwork can provide a mold growth food source. Wet fiberglass will also promote bacteria growth and result in a noxious odor.

**Final Solution:** AET's CIH developed and oversaw the implementation of an HVAC modification design change as well as the remediation of the moisture impacted ductwork. Approximately 70 feet of ductwork was removed/replaced. Work was performed in a negative pressure containment to control mold spore/bacteria release during the remediation process. Work was performed after normal business hours while the branch was kept operational. Project closeout included strict visual inspection/odor assessments as well as mold spore air quality sampling to verify the effectiveness of the remediation process.

Considerations for adjusting discharge temperature to existing HVAC units can include, increasing fan speed, modulating of Freon flow, adjusting return/outdoor air mixing. Additionally, in-line heater elements can be incorporated to prevent short cycling of equipment and build-up of humidity. Vigilance in post monitoring of adjustments is essential to ensure that proper operational parameters are maintained for occupant comfort and equipment efficiency.
