Case Study - Condemned Building to be Demolished

Project Description: County Community Development Preparation of Demolition Specifications and Project Management

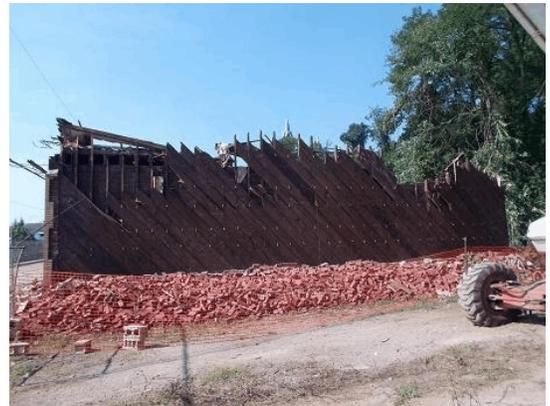
1. The building was structurally unsound and in danger of imminent collapse. The structure was covered with vegetation inhibiting an evaluation of structural integrity of the building. Roof collapse halted entry into the interior of the structure to evaluate any potential hazardous materials within.
2. The 4-story brick structure was constructed on an extreme slope. The north, east and west walls were constructed on grade but the south wall/foundation extended approximately 40 feet below into a ravine (almost a 90° slope).
3. At the southeast corner of the building, the foundation adjoined a pedestrian/traffic bridge. The front sidewalk of the building also abutted the building and the bridge.
4. Removal of several tall trees along with demolition and subsequent regrading had to be performed in close proximity to an occupied home which was located below the structure in the ravine.
