Case Study - Rubber Membrane Roof Replacement

Project Description: Asbestos Testing West Virginia Courthouse Roof

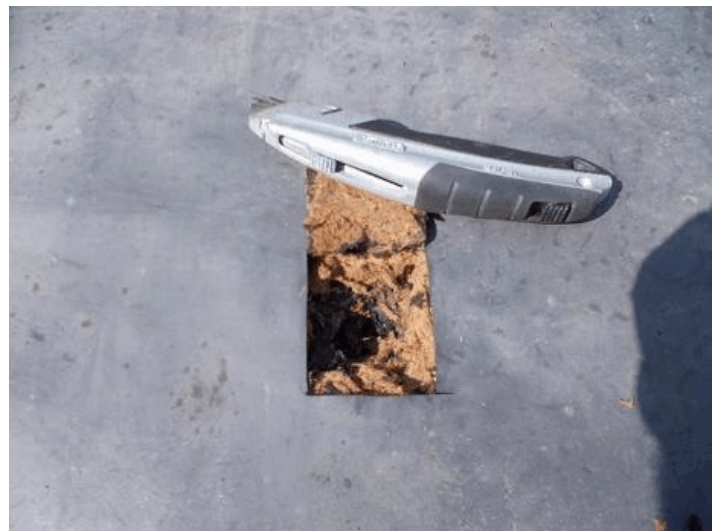
- a. For roof replacement projects, roof sampling locations must be adequately repaired/sealed to prevent future water infiltration. The courthouse is occupied and roof replacement may not occur until months after sampling. Care and specific training/products are essential when sampling rubber membrane roofs; sampling holes can create leaks and void roof warranties.

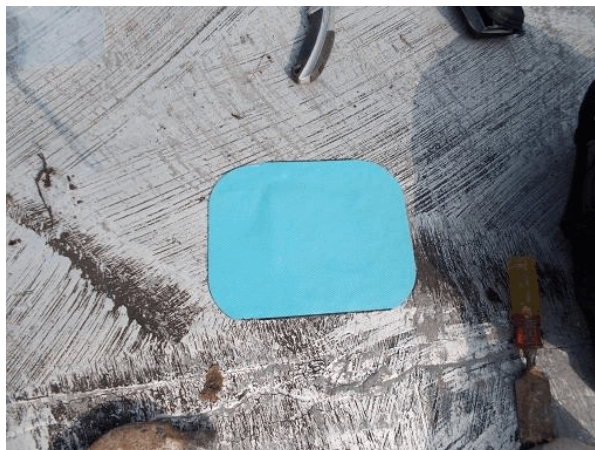
- b. A razor knife was used to cut three sides of an approximate 3" square hole into the rubber membrane leaving a flap to cover over later.
- c. A hammer/chisel was used to collect a bulk sample of each separate layer below the membrane. Water was used to wet/control fiber release during sampling. Samples were placed in resealable plastic bags, uniquely numbered and submitted to the laboratory. Sampling continued down to the wood substrate at each location.

- e. Weatherbond 710 corner covers (a 7" x 9" self adhesive patch) was installed over the sampling hole.
- f. DAP watertight asphalt sealant was used to seal the perimeter surfaces of the patch.

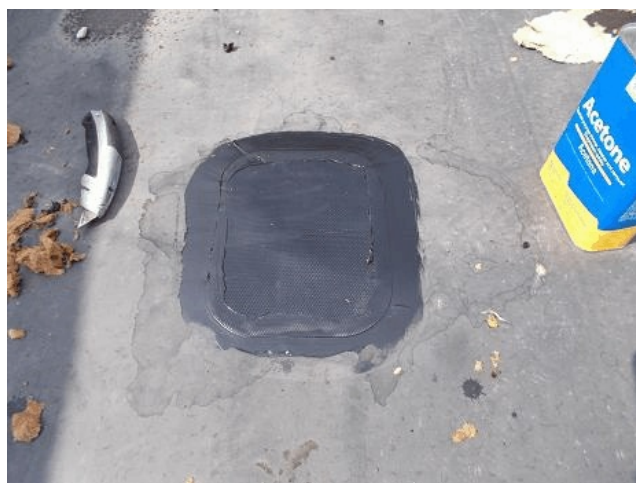
AET's Building Inspector determined that each roof section contained similar building components/materials. No differentiation in either visual assessment or sampling results could be determined. The entire roof was deemed to be asbestos containing and must be removed in accordance with West Virginia Asbestos Regulations.
