## **Case Study - Excessive Moisture in Concrete Floor Slab (Aldehydes)**

### **Project Description: Odor Investigation Carpet Squares in New Construction**

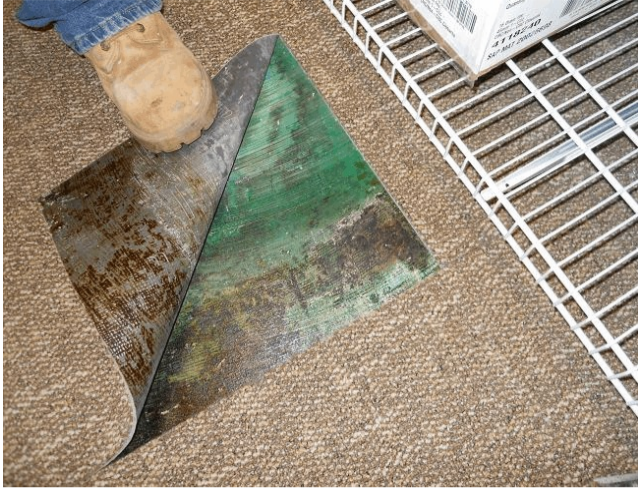
AET's visual inspection of the retail space found no evidence of water damage or exposed mold growth. Six roof-top HVAC units servicing the building were inspected and it was determined only 1 of 6 was in operation (at 100% outdoor air). AET perceived odors only in the carpeted areas of the retail space.

1. **Calcium Chloride Surface Testing** - was performed to evaluate the amount of moisture being released from the concrete floor slab. Testing confirmed the concrete had not properly cured and was releasing moisture to the back side of the carpet squares.
2. **VOC Air Sampling** - was performed for suspect chemical associated with the degradation of the carpet squares. Degradation occurs as a result of the excessive moisture and the high pH created.

Air sampling confirmed a significant level of aldehydes (above background in the retail space). Aldehydes have a low odor threshold of 15-120 ppb and can release a pungent, foul odor.

The building HVAC system was adjusted; all 6 HVAC units were operated at 15% outdoor air. The carpet squares were removed and replaced.
