CASE STUDY: CHROMIUM VI (Cr VI) SURFACE DEBRIS/STAINING

Project Description: Boiler and Cooling Water Treatment Lead Chromate Corrosion Inhibitors

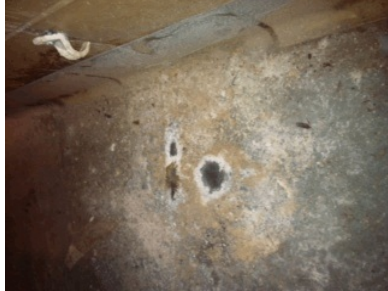
1. **Visual Inspection:** Evidence of a cream or light colored debris or staining was noted in several secondary pump rooms.
2. **Bulk Sampling:** Samples of debris were collected and found to contain low concentrations of Cr VI, Chromium III and lead. No MSDS were available for review to identify the specific corrosion inhibitor used. Review of the current water treatment chemicals found no lead or chromium content.

Remediation: Although the current corrosion inhibitors used in the water treatment system did not contain lead or chromium, disturbance of the existing surface debris in mechanical areas during sweeping, cleaning, etc. can result in airborne toxic chemical exposures. Cleanup of the surface debris was performed by first isolating the secondary pump room followed by HEPA vacuuming and wet wiping all surfaces. Exposure monitoring results found airborne Chromium VI levels approximately 15% OSHA's PEL and 29% AL during cleaning activities. Workers performing cleanup activities wore NIOSH approved respiratory protection and protective clothing.
