CASE STUDY: ODOR FROM STORED, USED CLEANING MATERIAL/ITEMS

Project Description: Odor Investigation Bank Branch Employee Breakroom

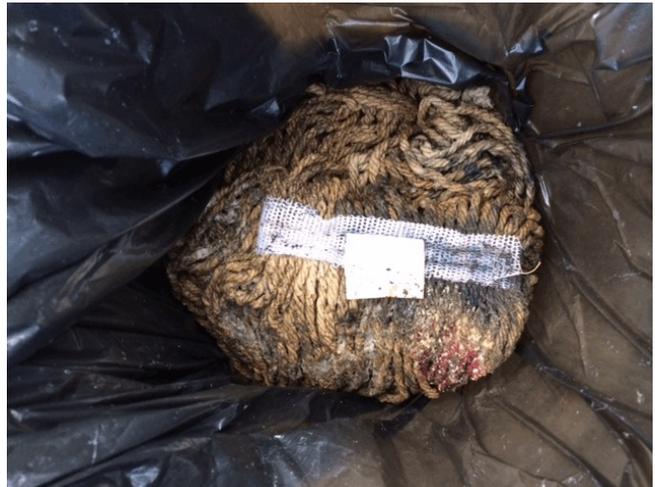
3. **Find the real odor source (Storage Room)...** Inventory inspection of potential odor sources including stored materials/items identified a bucket wrapped in two plastic bags containing a damp, decomposing cotton mophead. The mophead was obviously stored by the user following a previous cleaning and since forgotten. The odor from the bucket closely matched the odor within the Employee Breakroom and determined to be the source of the complaint.

CONCLUSION: Upon discovery of the improper stored material, AET removed the entirety of the bucket and mophead outdoors for disposal. Once the breakroom was ventilated, the associated odor complaints ceased. AET reported the finding, proactive response and discussed recommended actions to eliminate potential reoccurrence of the event.
