## ODOR INVESTIGATION 101: PUNGENT “VOMIT-LIKE” ODOR

### FOLLOW YOUR NOSE.... THEN JUST FIX IT

### Recent Case Study: Emergency response to an odor complaint at a bank branch location

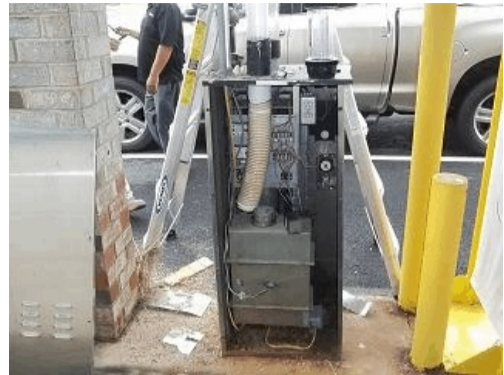
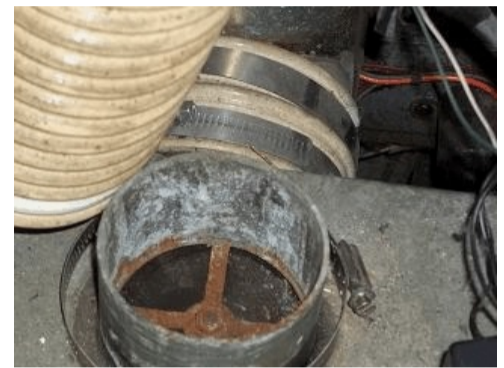
3. Accumulation of solid materials, trash, lack of cleaning, old stored items, decomposing, etc. (*ruled out by visual inspection*)
4. Drive through document carrier tubes: This vacuum system operates to bring deposits, withdraws, and other items into the bank through tubes via the drive through area. These tubes once inside the bank also extend through a ceiling plenum. A similar pungent “vomit-like” odor was perceived by the inspector during the use of this system. The system was partially disassembled, and the same odor was noted inside the lower blower assembly.

**END RESULT:** The blower assembly was replaced and the carrier tubes cleaned. Reports of odors ceased.
