CASE STUDY: HVAC WHALEN UNIT MALFUNCTION

PROJECT DESCRIPTION: MOLD REMEDIATION MID-RISE ELDER CARE FACILITY

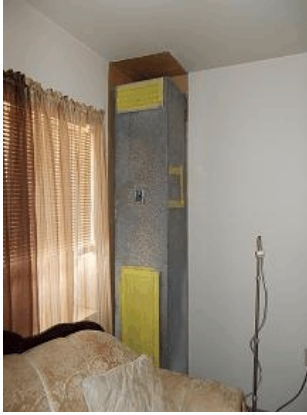
Whalen units at this facility are comprised of a single supply down comer and return riser (two pipe system) served by a central boiler/chiller water system. Whalen units are built into the walls of each apartment (enclosed in drywall) and the only openings into the apartment is for the supply and return grills. Temperature control is by a local thermostat for each individual Whalen unit. Room air is drawn in from the return grill on the bottom of the unit, conditioned, and exhausted from the supply grill located at the top of the unit. Typically, outdoor air is provided by a separate centralized unit in common areas within the facility.
