Case Study - Moisture/Mold Remediation - Water Permeating Below and Through the Concrete Floor Slab

Project Description: Certified Industrial Hygienist (CIH) Oversight - Mold Inspections, Project Design, Remediation, Restoration and Reconstruction.

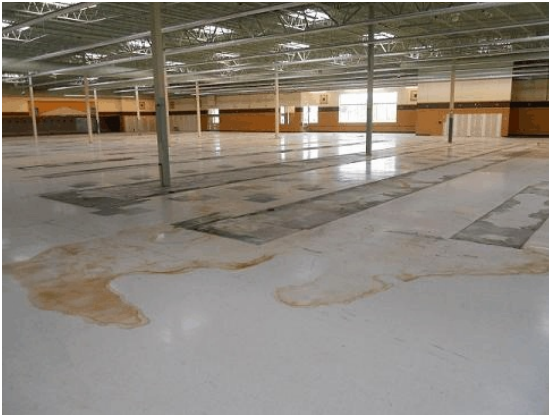
Scope of Services: Accredited Environmental Technologies, Inc. (AET's) CIH staff was contracted to oversee restoration and reconstruction following a severe thunderstorm which resulted in the flooding of a large TV Production Studio, Office, Warehouse and Worldwide Distribution Facility. This facility operates 24/7. Tens of thousands of dollars in damages occurred to building materials and content when storm water permeated up through the concrete floor slab in a centralized location away from any perimeter foundation walls.

Mold Remediation - AET's CIH developed a Moisture/Mold Remediation Work Plan and coordinated the phasing of the remediation process. Work was performed in negative pressure containments, vented with HEPA filtration units. Individual work areas were individually inspected, moisture tested and mold spore air quality evaluated to verify the effectiveness and completeness of the remediation process. Reconstruction activities were also monitored for compliance with OSHA's Health and Safety Standards and to address/control odors, dusts, fumes and VOCs, released during work. Work was completed on a month schedule with minimal impact to normal business operations.

Final Corrective Actions - Included the installation of a new roof storm water drainage system. Additional roof drain collection points were added which fed to a new dedicated feeder system. A large french drain system was also installed.
