Case Study - Health Hazard Evaluation

White Dust from Humidifier

Project Description: IAQ Occupant Complaint, Apartment Building

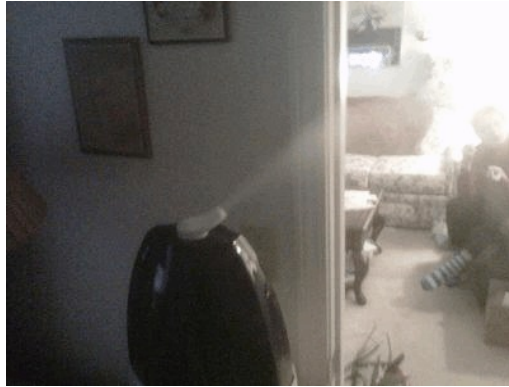
2. **Moisture Testing:** No areas of moisture impact were identified via Infrared thermography or moisture meter testing.
3. **Particle Counter Sampling:** Total particulate level (0.3 micron size) were approximately 7 times higher within the apartment unit compared to outdoors. The source of the elevated particulate readings was quickly traced to the operation of the tenant-owned humidifier. The humidifier was observed releasing "white dust" into the air of the apartment with some dust accumulation on adjacent apartment surfaces.

4. **Tape Lift Sampling:** White dust accumulations were tested microscopically and found to contain insignificant levels of mold spores or fiberglass.

Conclusion: Recommendations were made for the tenant to consult their pulmonary specialist regarding continued humidifier use and following manufacturers instructions for cleaning and filter changing for the humidifier. A cursory cleaning of the apartment was also performed and air scrubbing of the apartment completed over a 48 hour period using an air filtration device equipped with HEPA filtration.
